ENVIRONMENTAL TECHNOLOGY

# Sealing the Steel & Metal Industry

- Section 1. A Guide to Slurries
- Section 2. Sealing Off/Onshore Exploration Slurries
- Section 3. Sealing Pulp & Paper Slurries
- Section 4. Sealing Mining & Mineral Slurries
- Section 5. Sealing Coal Fired Power Industry Slurries
- Section 6. Sealing Steel & Metal Industry**  
Pumps, Rolls, Electric Motors, Pillow Blocks,  
Gearboxes and Fans

<b>Steel &amp; Metal Industry</b>		
	<b>Section 6</b>	<b>Contents</b>	<b>1</b>
	AESSEAL plc L-UK/US-SLURRY-03	+44 1709 369966 Issue 3	www.aesseal.com Copyright © 2007 AESSEAL plc

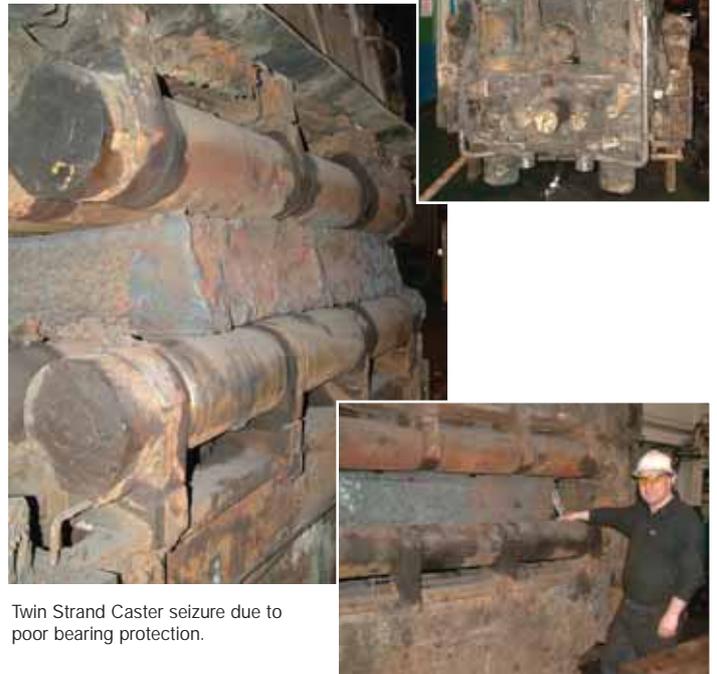
The net result is that the combination of a non-uniform material thickness and bent rolls means that the slab gets stuck between the rolls, as shown in the photo to the right.

Once stuck, the slab slowly cools and solidifies creating one huge headache for the plant engineers who then have to stop the production line and somehow remove the solidified material before the equipment can be reused.

Twin Strand Caster seizure due to poor bearing protection.

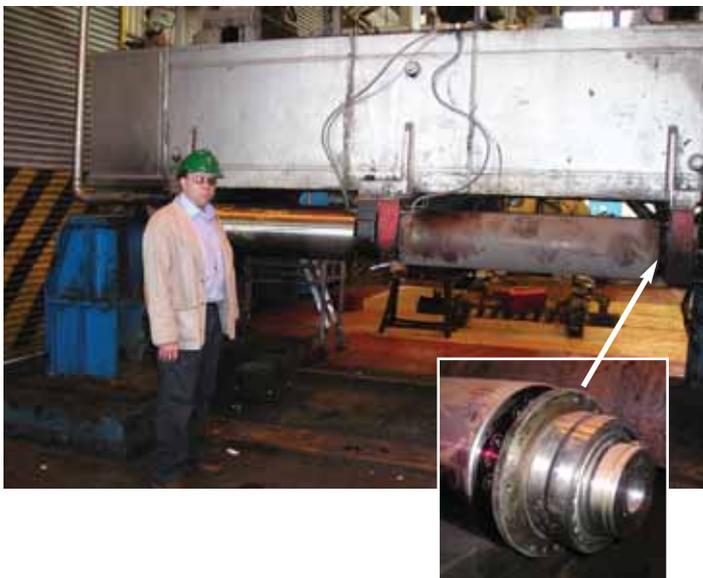
The photos to the left shows the twin strand continuous caster, sited in a steel mill in the UK.

To eliminate bearing deterioration and roll misalignment as previously described, flange mounted LabTecta™ bearing seals may be installed at either end of the roll. The net result is a roll that is less susceptible to bearing deterioration, therefore will permit the material to be cast in longer production runs. By simply protecting the bearings with LabTecta™ seals, the plant-wide savings are immense.

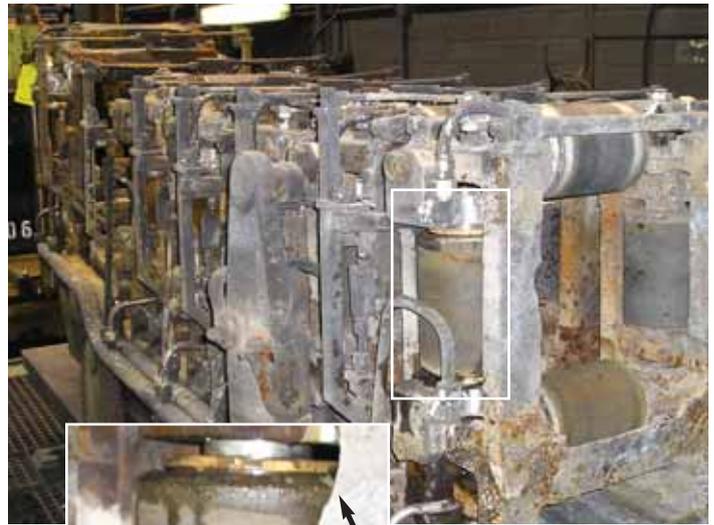
Continuous Caster.

The photos to the right show an alternate continuous caster sited in a steel mill in Germany.

The rolls in the continuous caster turn extremely slowly and are grease lubricated. Traditionally, these are sealed with lip seals which permit contaminants to enter the bearings destroying them after a typical three week production run. The poor bearing life costs the plant many thousands of Euros in lost production time, repair and replacement parts.

Contaminants are created as the abrasive dross/slag forms on the molten metal at 1,200°C (2,192°F). The close proximity of this to the lip seals and the poor sealing performance of the lip seals, means that it is inevitable that the bearings will be effected.

The plant has installed 300 LabTecta-TE™ bearing seals on each side of the water cooled rolls after finding that the bearings remained in excellent condition after a considerable production run.

A steel mill in Germany was looking for a better solution to the existing lip seals on their rolls in the continuous caster. After a typical three week production run, the lip seal and bearings would be completely destroyed by the abrasive dross/slag forming on the molten metal at 1,200°C (2,192°F) near the seal.

The customer tried two 50mm LabTecta-TE™ seals on each side of the roll (water cooled) and after the same three week production period the LabTecta™ seals and the bearings were in excellent condition.

The rolls turn extremely slow and are grease lubricated. Subsequently the customer has order further LabTecta™ seals given there excellent performance.

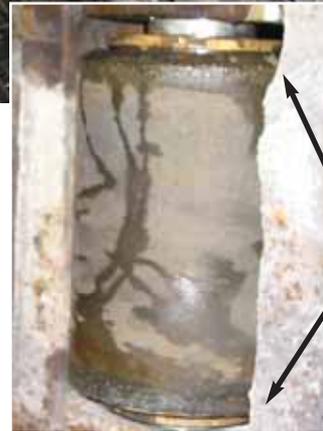
LabTecta-TE™

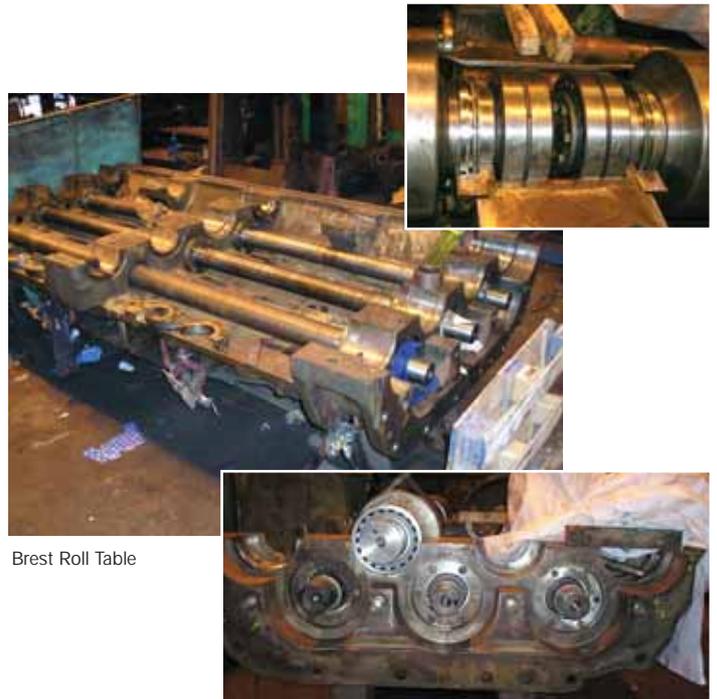
An alumina works in the UK approached AESSEAL® to protect their Brest Roll Table bearings, shown right.

The Brest Roll Table processes aluminium sheet, reducing it in thickness for use in aluminium drink cans and tin foil.

If the roll bearings are contaminated with debris, wear occurs which in turn causes radial movement of the roll. This movement changes the thickness of the rolled material leading to many plant problems, including scrap and re-work.

Each Brest Roll Table requires 21 LabTecta™ bearing seals and the first set was installed in 2006.

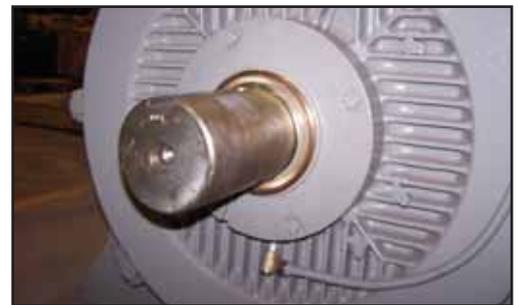
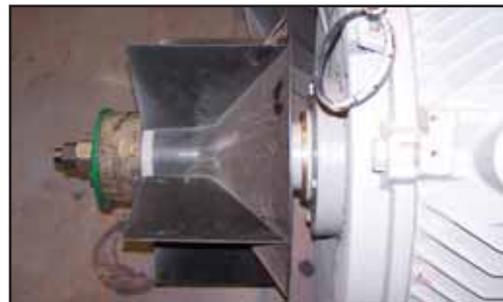
Given the LabTecta™ seals IP55 certification and conformance to IEEE 841-2001, the alumina works purchased 140mm standard LabTecta™ seals for both the drive and fan end of the motor. The motors have been running well ever since.

LabTecta™ installed on an electric motor.

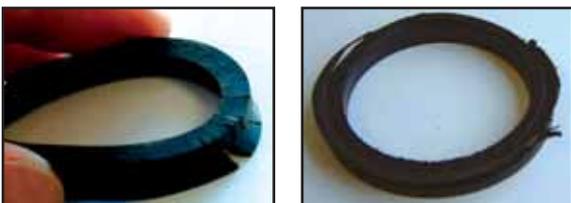
It took around 0.3 of a second to realize that after a few hours the rubber v-ring would look something like the one that AESSEAL® tested in the laboratory, below.

Conventional v-ring after a few hours of dynamic equipment operation.

**FACT: AESSEAL® purchased an industry standard IP55 electric motor and ran it dynamically for 500 hours. When it was re-tested it failed the IP55 test.**

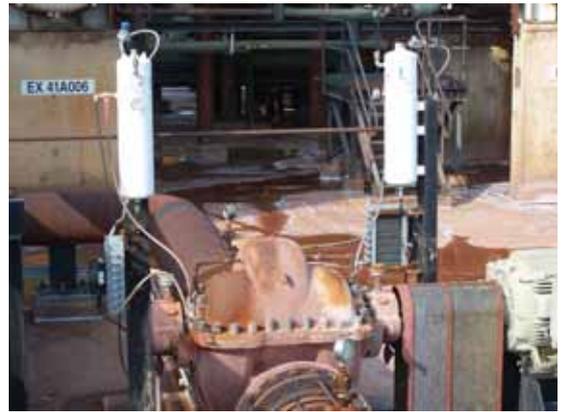
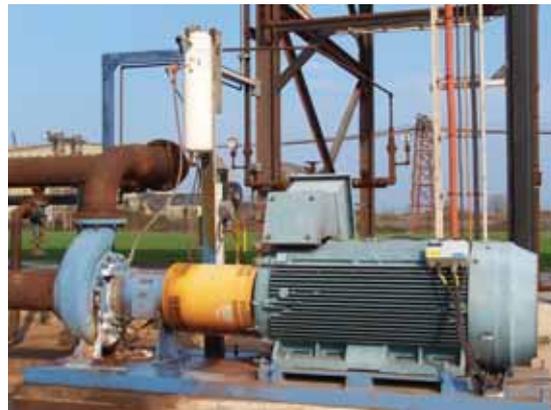
The photos to the top right show a double mechanical seal supported by a 25 liter / 6.60 gal (US) support system with air blast coolers installed in an alumina plant in Ireland. This is one example of how the equipment life can be extended by changing the sealing environment.

SSE25™ system with air-blast coolers installed in an alumina plant in Ireland.

In 2004 an alumina processing refinery in Ireland asked AESSEAL® to specify a Seal Support System to be used with two DMSF™ seals on a new installation of two pumps. The pumps are pumping caustic liquor. AESSEAL® designed a Seal Support System consisting of a single SW2™ with 25 liter / 6.64 gal (US) vessel size with an air blast cooler to feed the two DMSF™ seals. The two pumps have been installed with the Seal Support System and DMSF™ seals for two years without any problems following updating of the outboard rotary face on the DMSF™ seals. MagTecta™ bearing protectors are also installed on these two pumps.

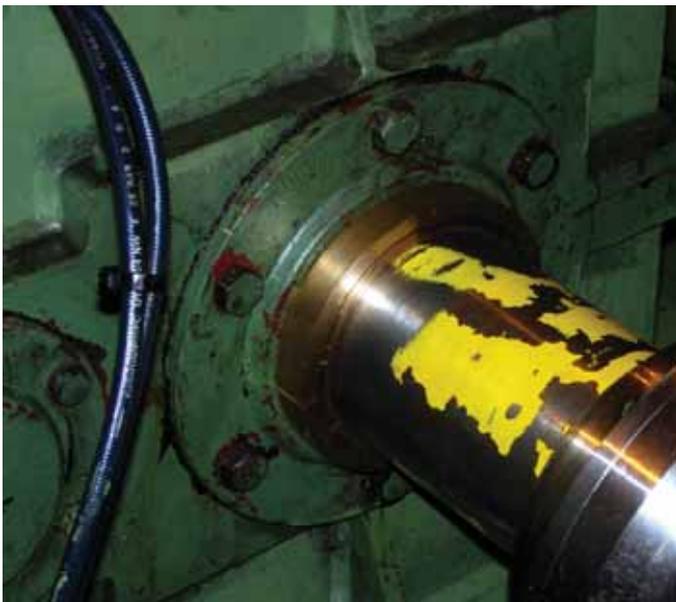
Case Ref: 3370 - 100mm LabTecta-RDS™ (Split seal) working on gearbox at 1,500rpm

A steel mill in Germany had trouble with lip seals on their gearboxes and required a split seal solution. The shaft size was 100mm (3.937") operating at a speed of 1,500rpm using standard gear oil.

The customer chose a LabTecta-RDS™ (Split Labyrinth Seal) which pressed into the existing lip seal cavity. The gearbox was installed in October 2006 and has been running well since.

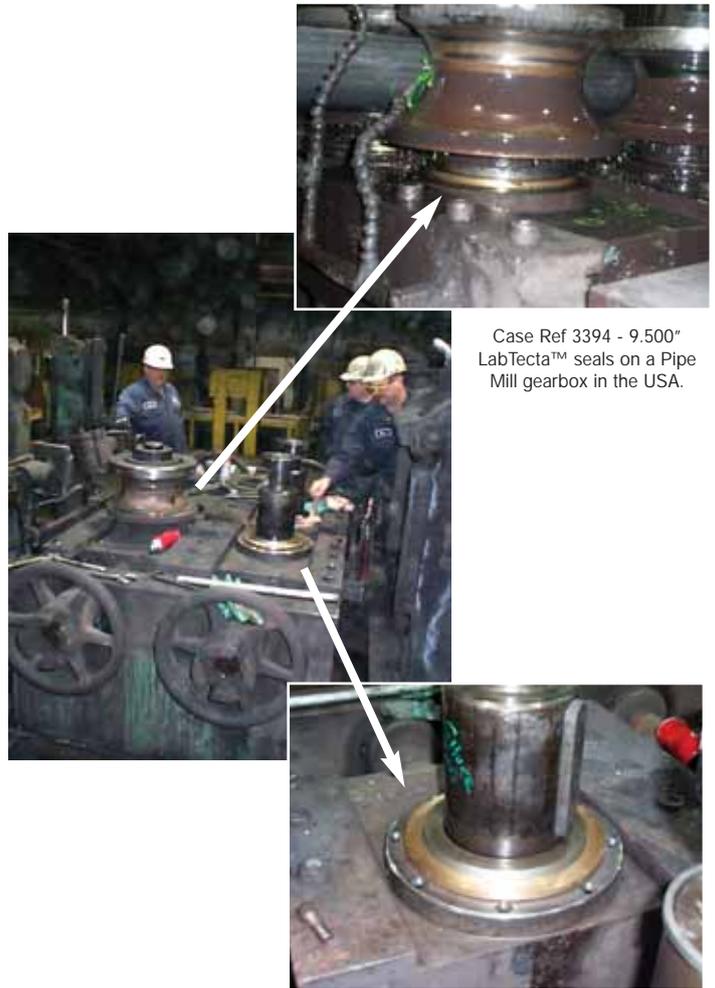
Case Ref 3394 - 9.500" LabTecta™ seals on a Pipe Mill gearbox in the USA.

The photos above show a gearbox in a pipe mill in the USA, where the plant engineers had constant problems with water passing through the lip seals on their vertical shaft guide rollers.

The plant engineers had to regularly drain the water from the gearbox and replace the bearing assemblies. After they installed the LabTecta-TE™ seals they were so impressed with the improved performance, they ordered further units to upgrade their other gearboxes.

In April 2007, 9.500" LabTecta TE™ seals were installed on two guide roll gearboxes for pipe weld line in a pipe making mill in the USA, replacing lip seals.

The guide rolls were quenched with water based cooling fluid and therefore the old sealing arrangement allowed fluid and pipe slag to enter gearbox, reducing the bearing life to typically six months.

Every six months, the bearings had to be replaced costing \$1,200 (£600) each. On top of this, the gearset costs plus other gearbox damage, labour costs and plant downtime meant that the low cost lip seals where actually costing the plant tens of thousands of dollars each year. The LabTecta-TE™ seals are currently running without problems.
